Your Inspection Report

16870 91st Avenue North
North Pole, MN 55555

RE: Report No. 1018, v.2
16870 91st Avenue North
North Pole, MN
55555

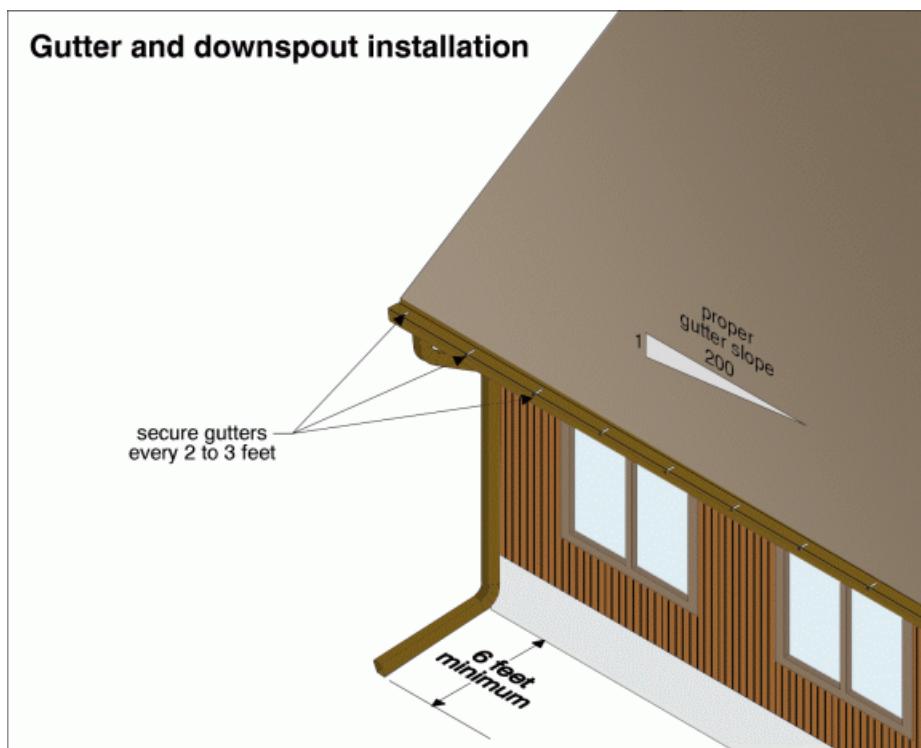
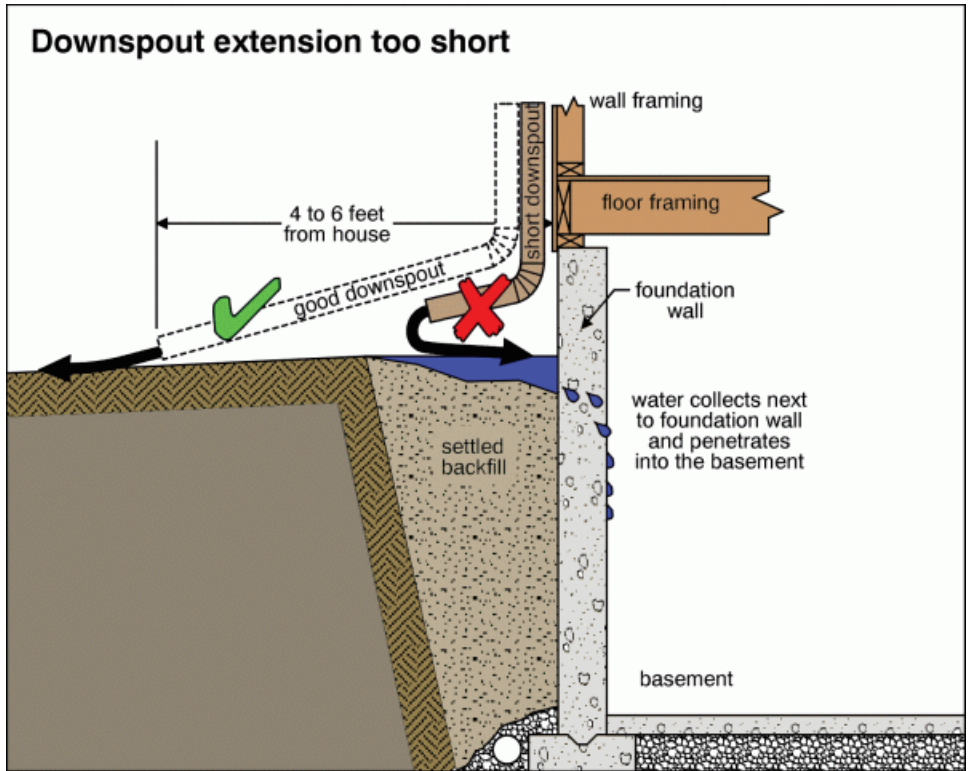
1. **Condition:** • [Should discharge 6 feet from building](#)

Implication(s): Chance of water damage to contents, finishes and/or structure

Location: Various Exterior Wall

Task: Repair

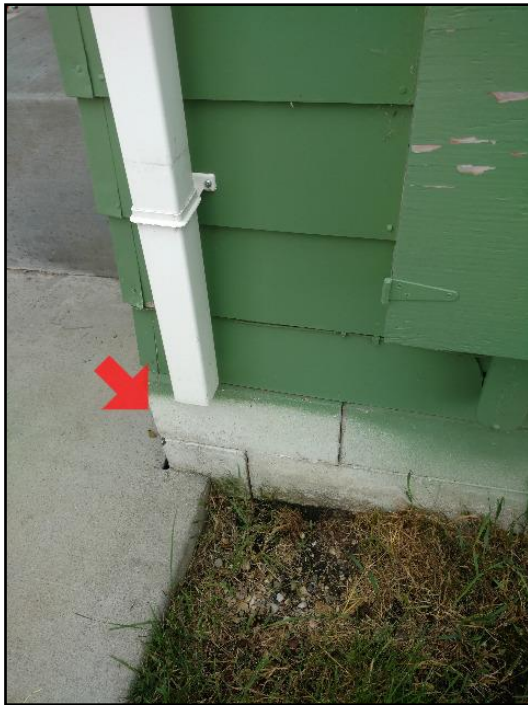
Should discharge 6 feet from building

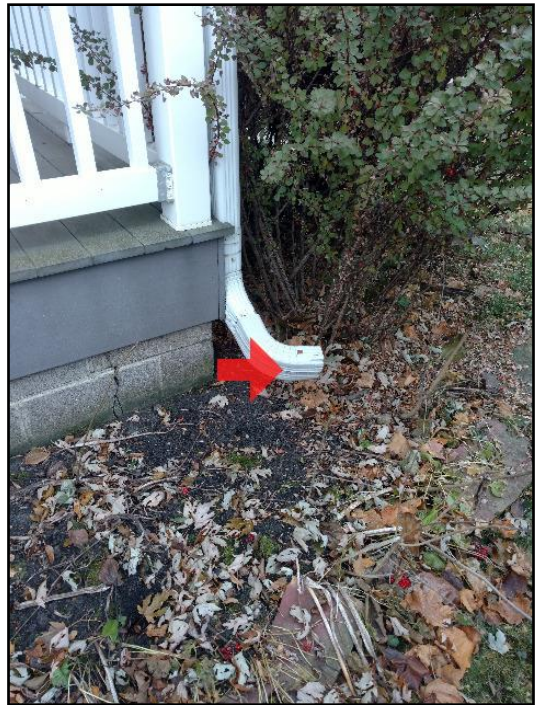
Should discharge 6 feet from building

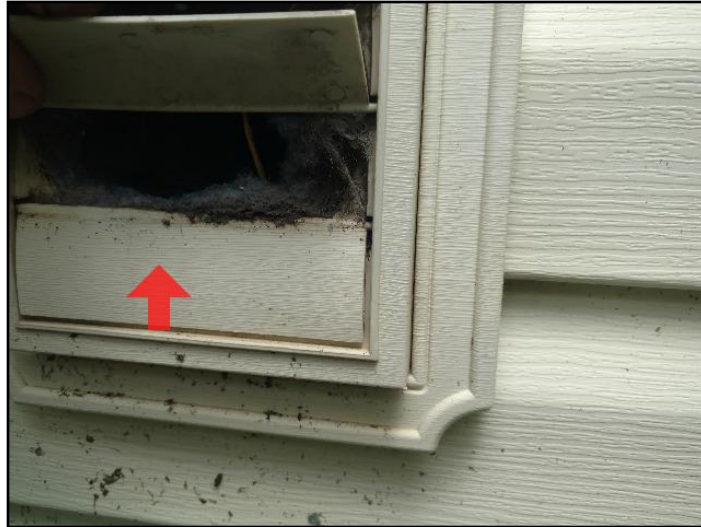
2. Condition: • The dryer vent needs to be cleaned

Location: North First Floor

Plugged dryer vent

Task: Clean

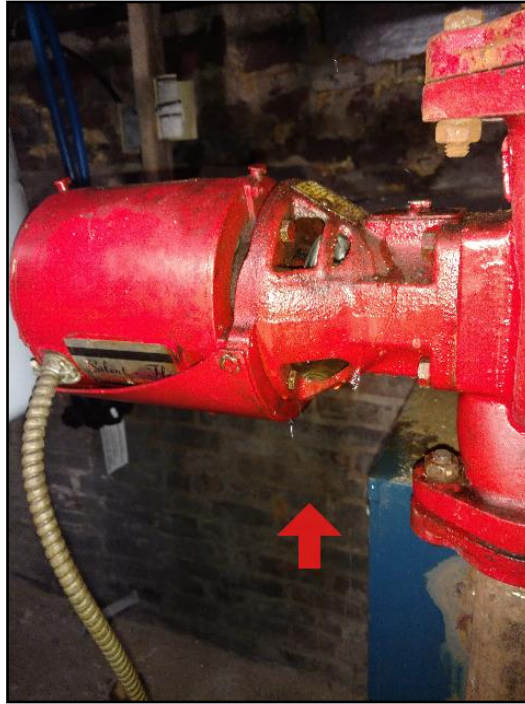
3. Condition: • The pump for the boiler is leaking

Location: Basement Utility Room

Leaking pump

Task: Repair

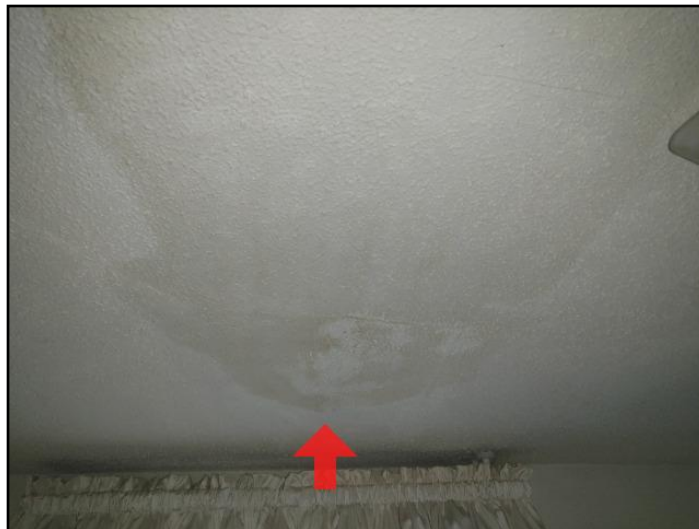
4. **Condition:** • [Patched](#)

Implication(s): Chance of damage to contents, finishes and/or structure

Location: First Floor Bedroom

Patched
